Construction in Photos

March 17 - 24, 2016

Water Resource Recovery Department Village of Ashville Ashville's Water Resource Recovery Facility Part A

Ashville's Water Resource Recover Facility Project Planning Timeline 2015 - 17

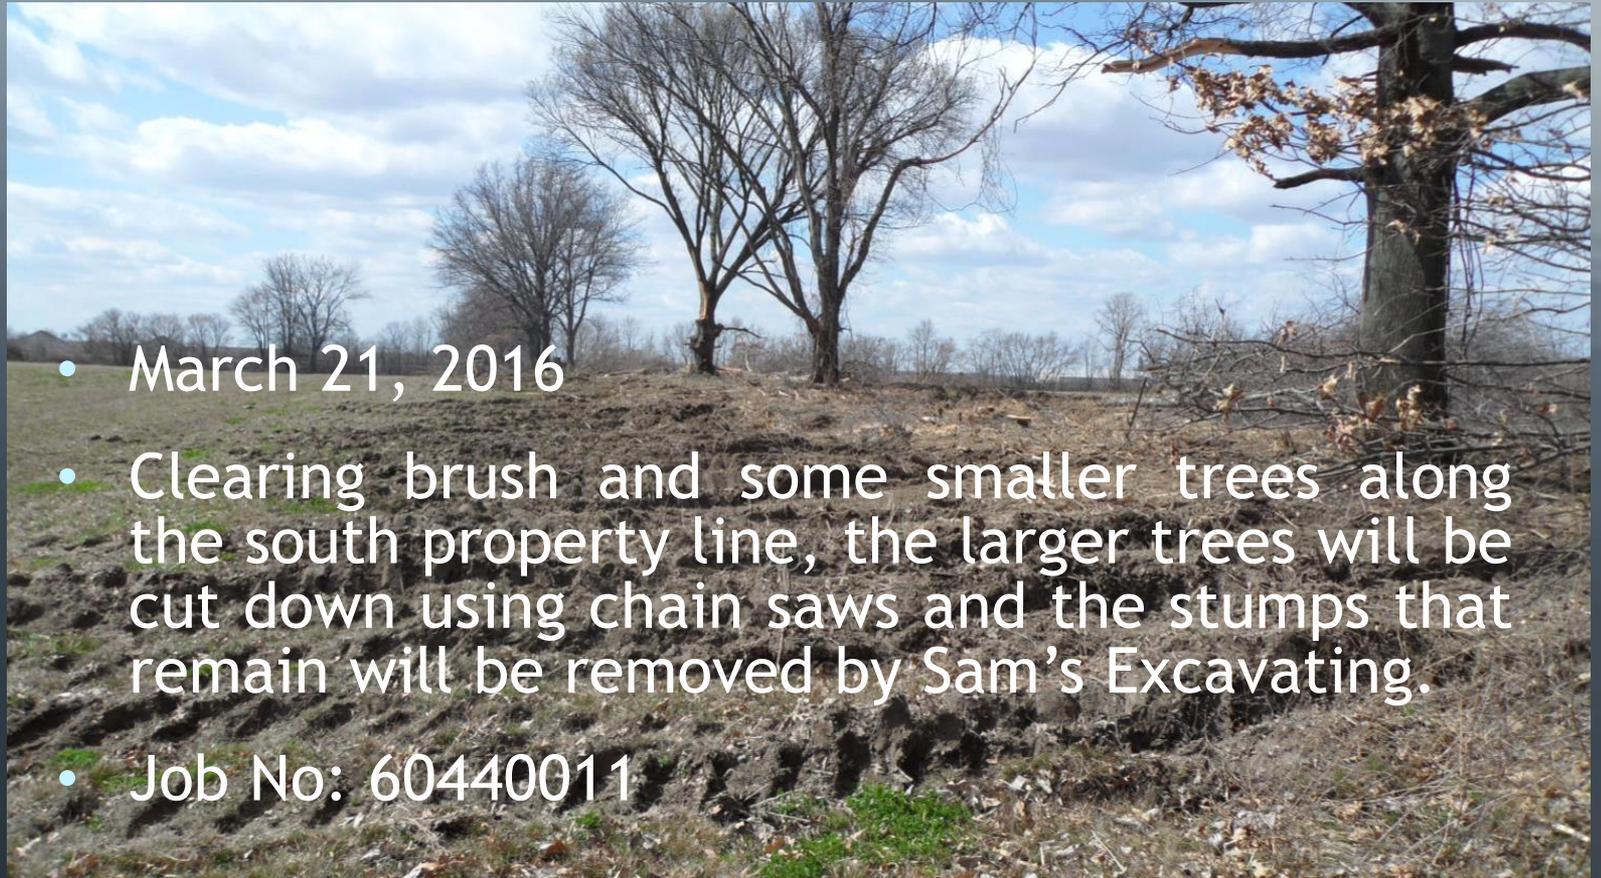
- March 21, 2016
- Clearing brush and some smaller trees along the south property line, the larger trees will be cut down using chain saws and the stumps that remain will be removed by Sam's Excavating.
- Job No: 60440011

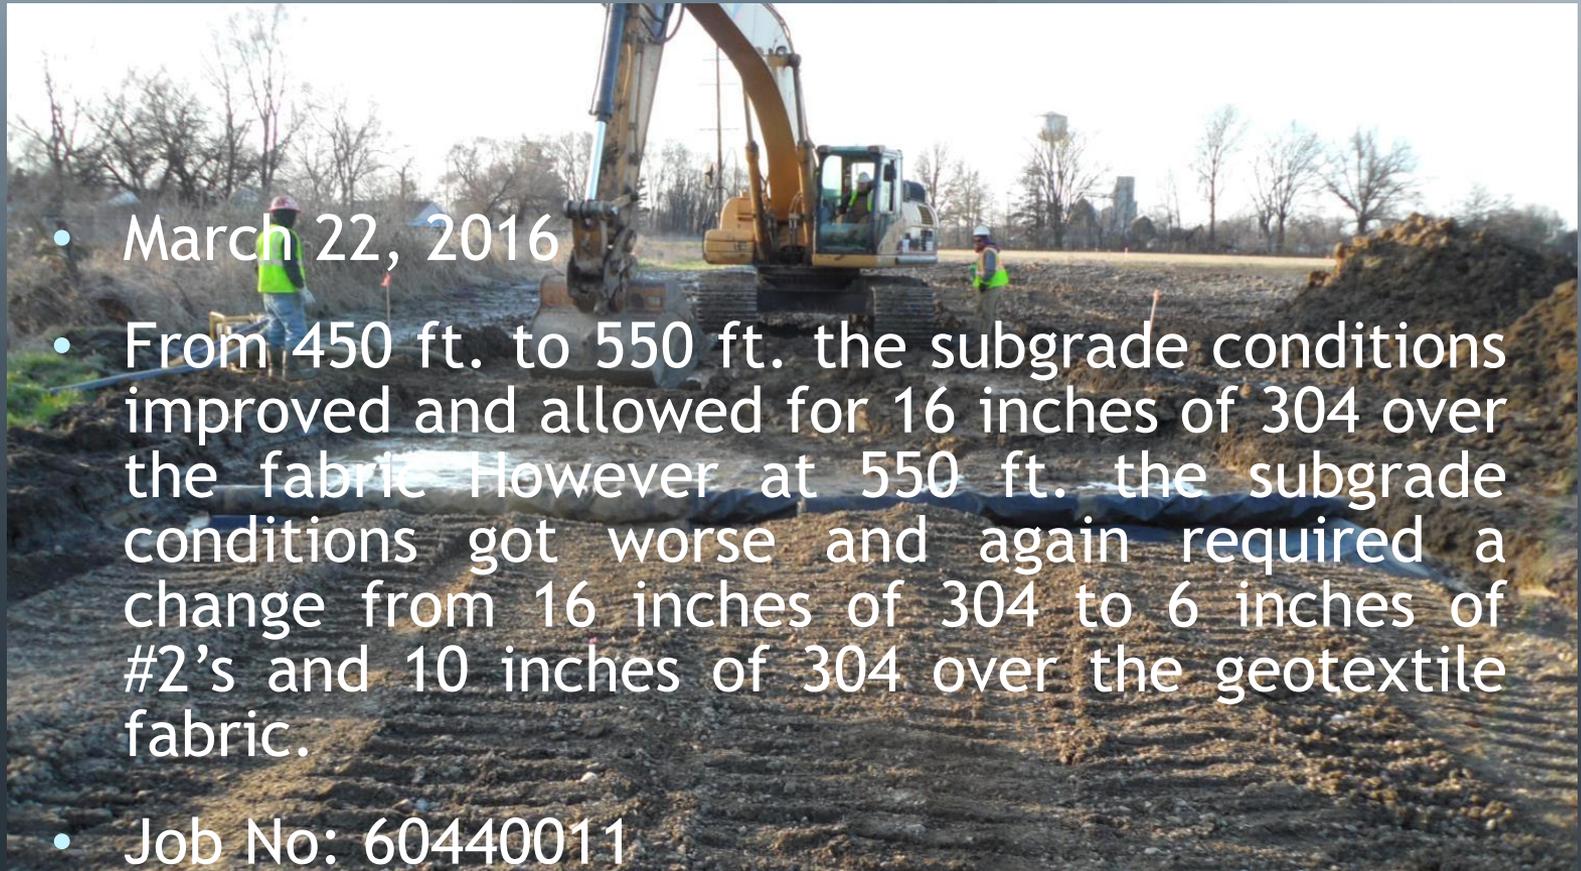
- March 22, 2016
- From 450 ft. to 550 ft. the subgrade conditions improved and allowed for 16 inches of 304 over the fabric. However at 550 ft. the subgrade conditions got worse and again required a change from 16 inches of 304 to 6 inches of #2's and 10 inches of 304 over the geotextile fabric.
- Job No: 60440011

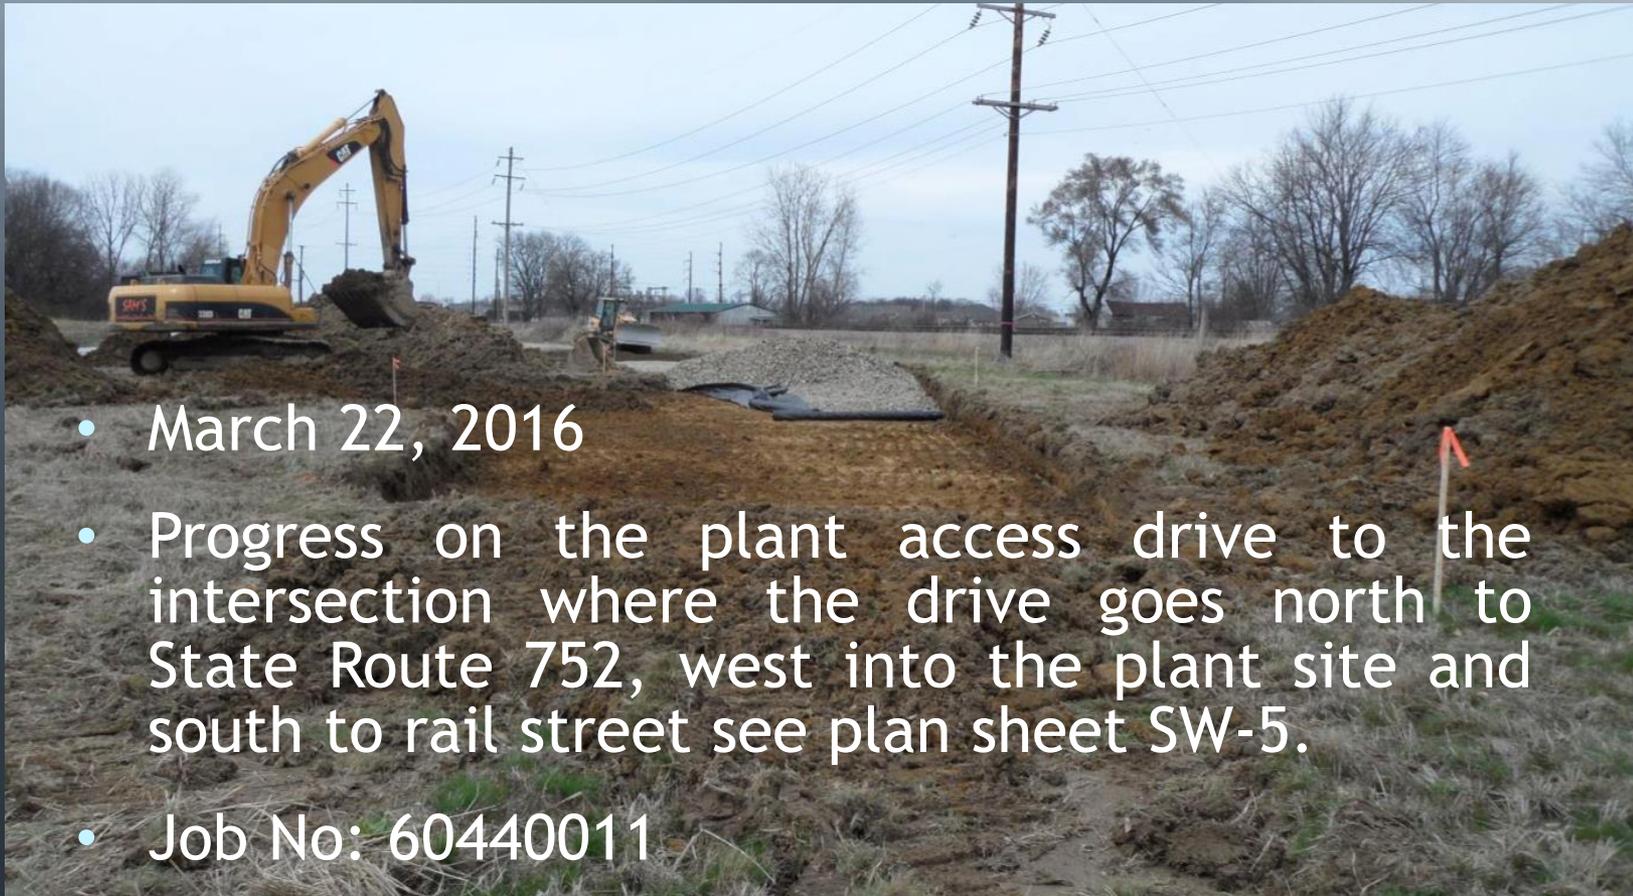
- March 22, 2016
- Progress on the plant access drive to the intersection where the drive goes north to State Route 752, west into the plant site and south to rail street see plan sheet SW-5.
- Job No: 60440011

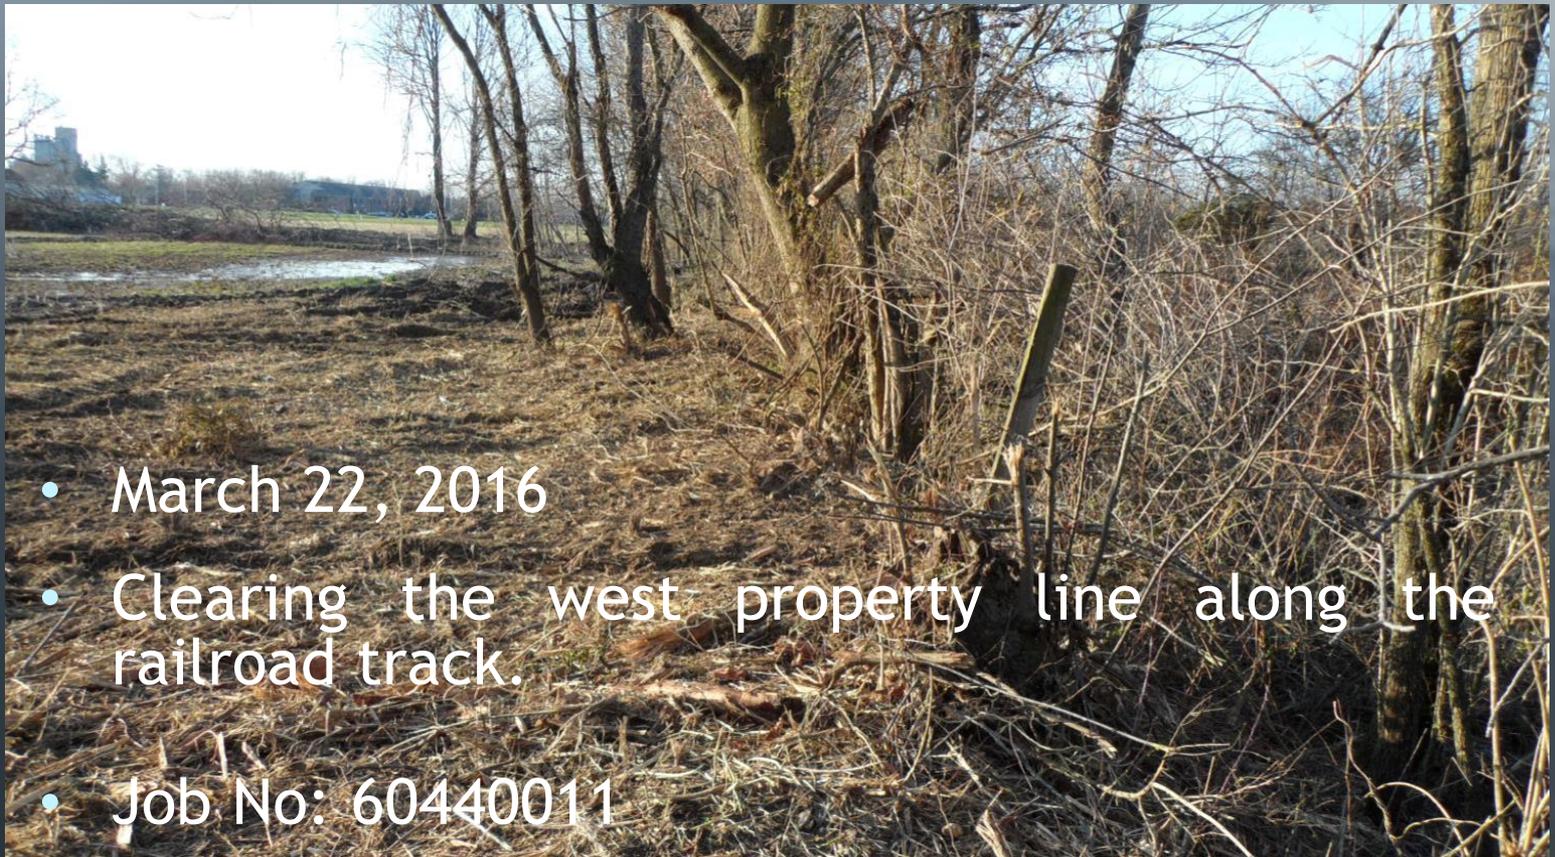
- March 22, 2016
- Clearing the west property line along the railroad track.
- Job No: 60440011

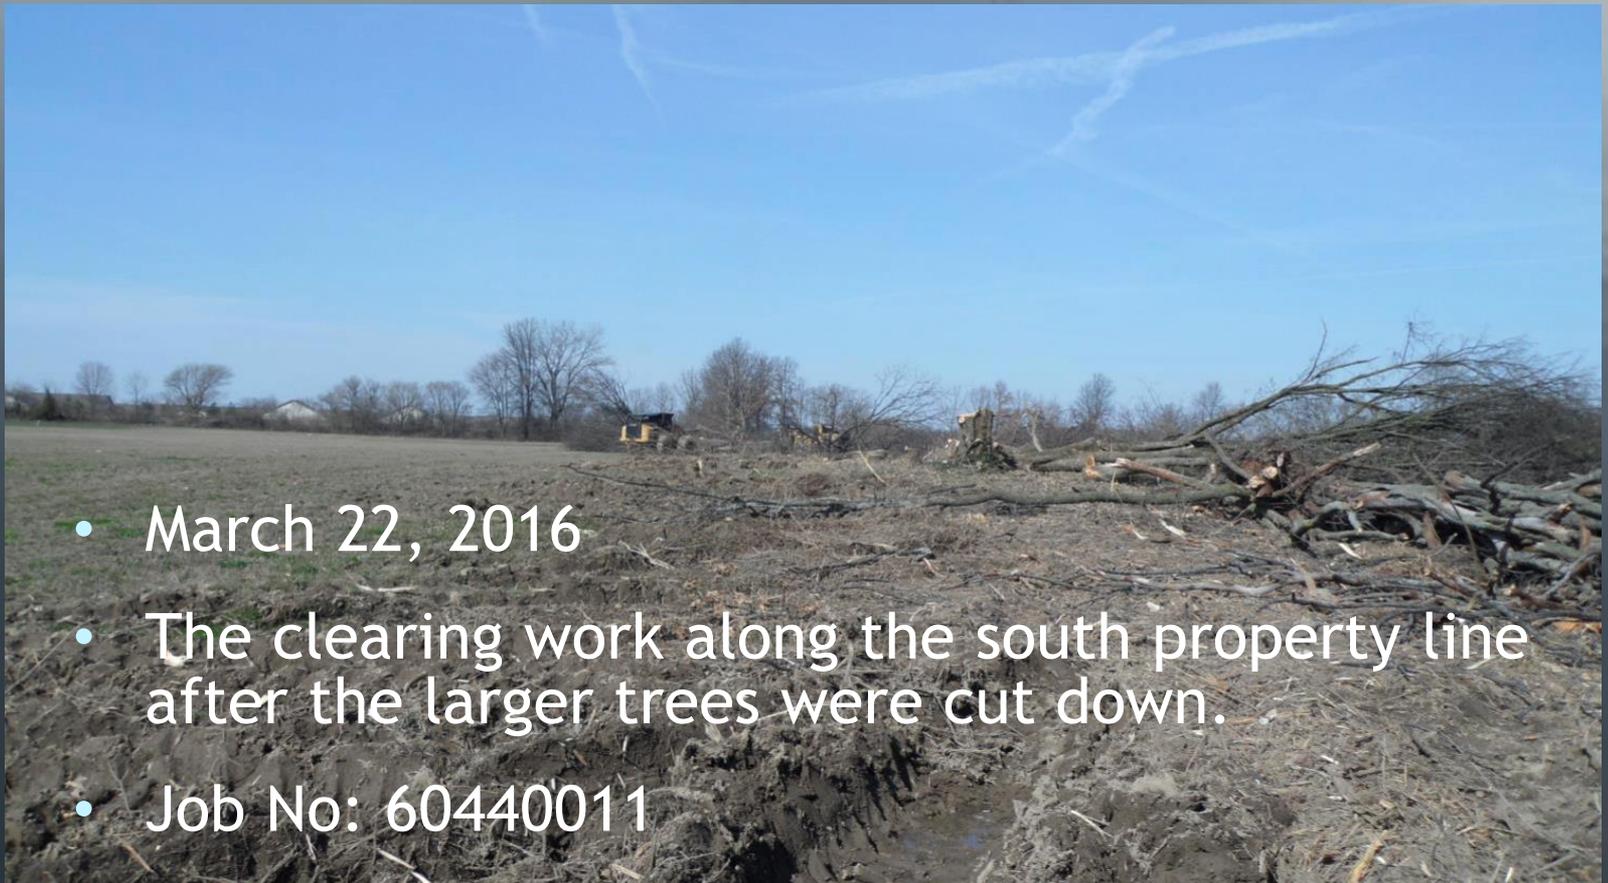
- March 22, 2016
- The clearing work along the south property line after the larger trees were cut down.
- Job No: 60440011

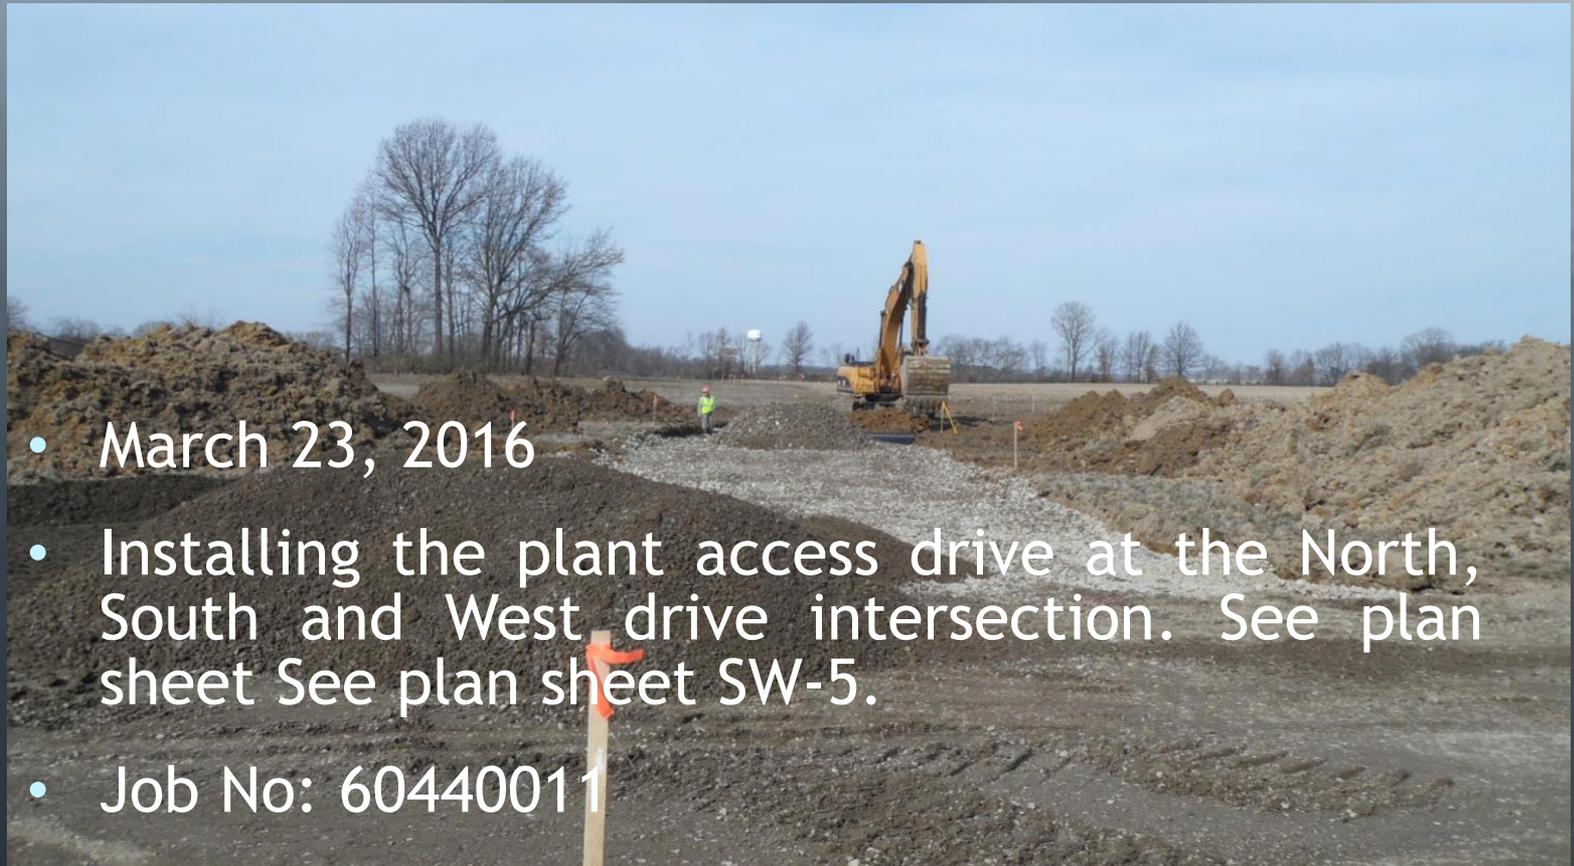
- March 23, 2016
- Installing the plant access drive at the North, South and West drive intersection. See plan sheet SW-5.
- Job No: 60440011

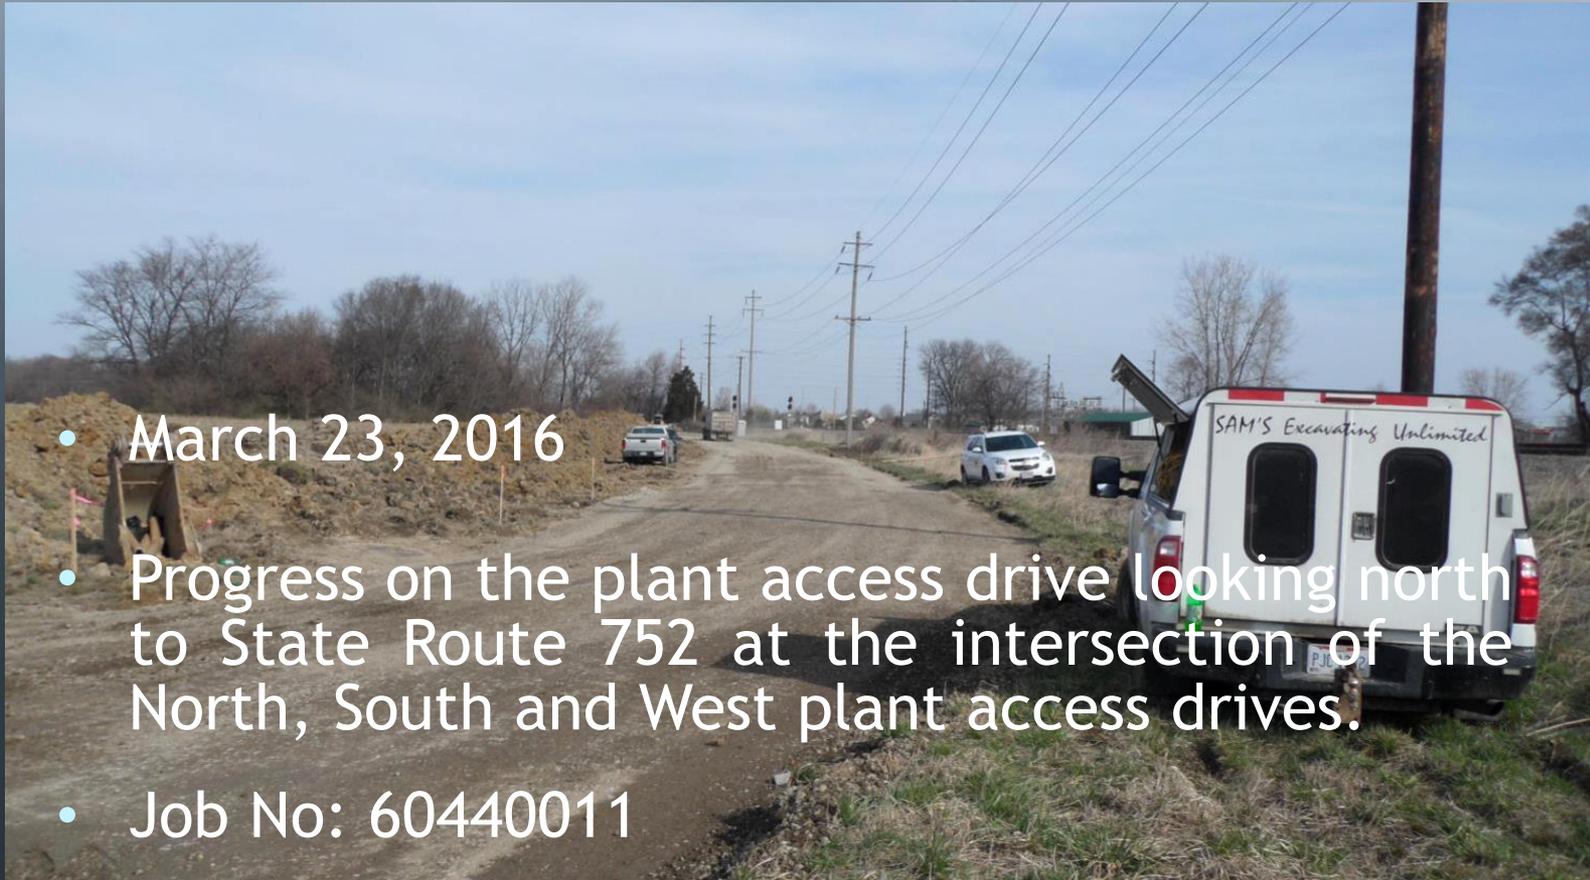
- March 23, 2016
- Progress on the plant access drive looking north to State Route 752 at the intersection of the North, South and West plant access drives.
- Job No: 60440011

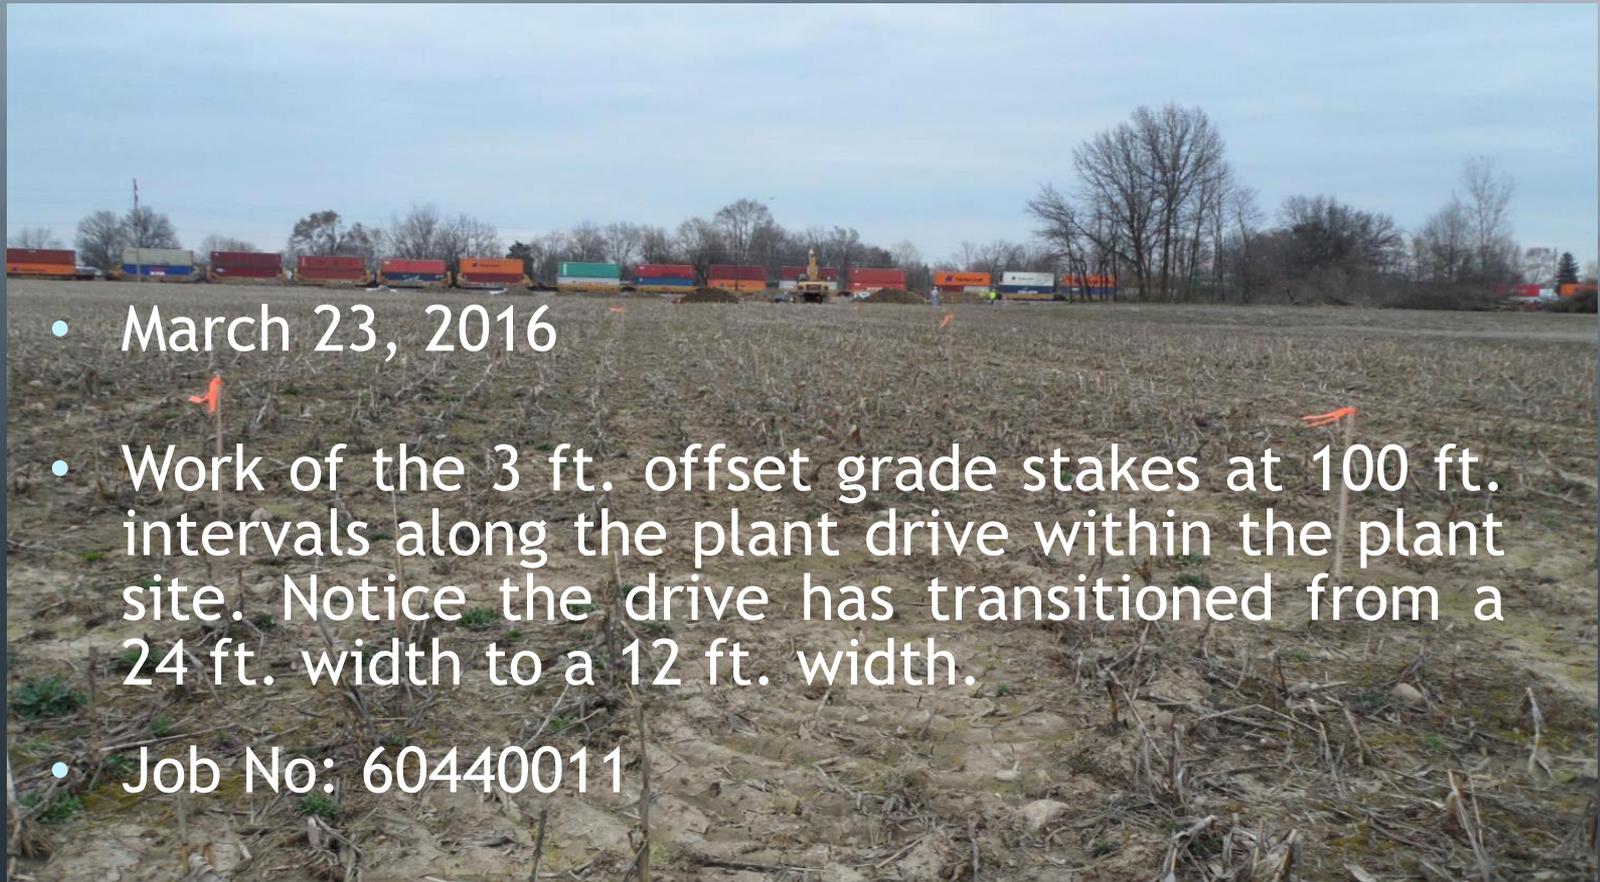
- March 23, 2016
- Work of the 3 ft. offset grade stakes at 100 ft. intervals along the plant drive within the plant site. Notice the drive has transitioned from a 24 ft. width to a 12 ft. width.
- Job No: 60440011

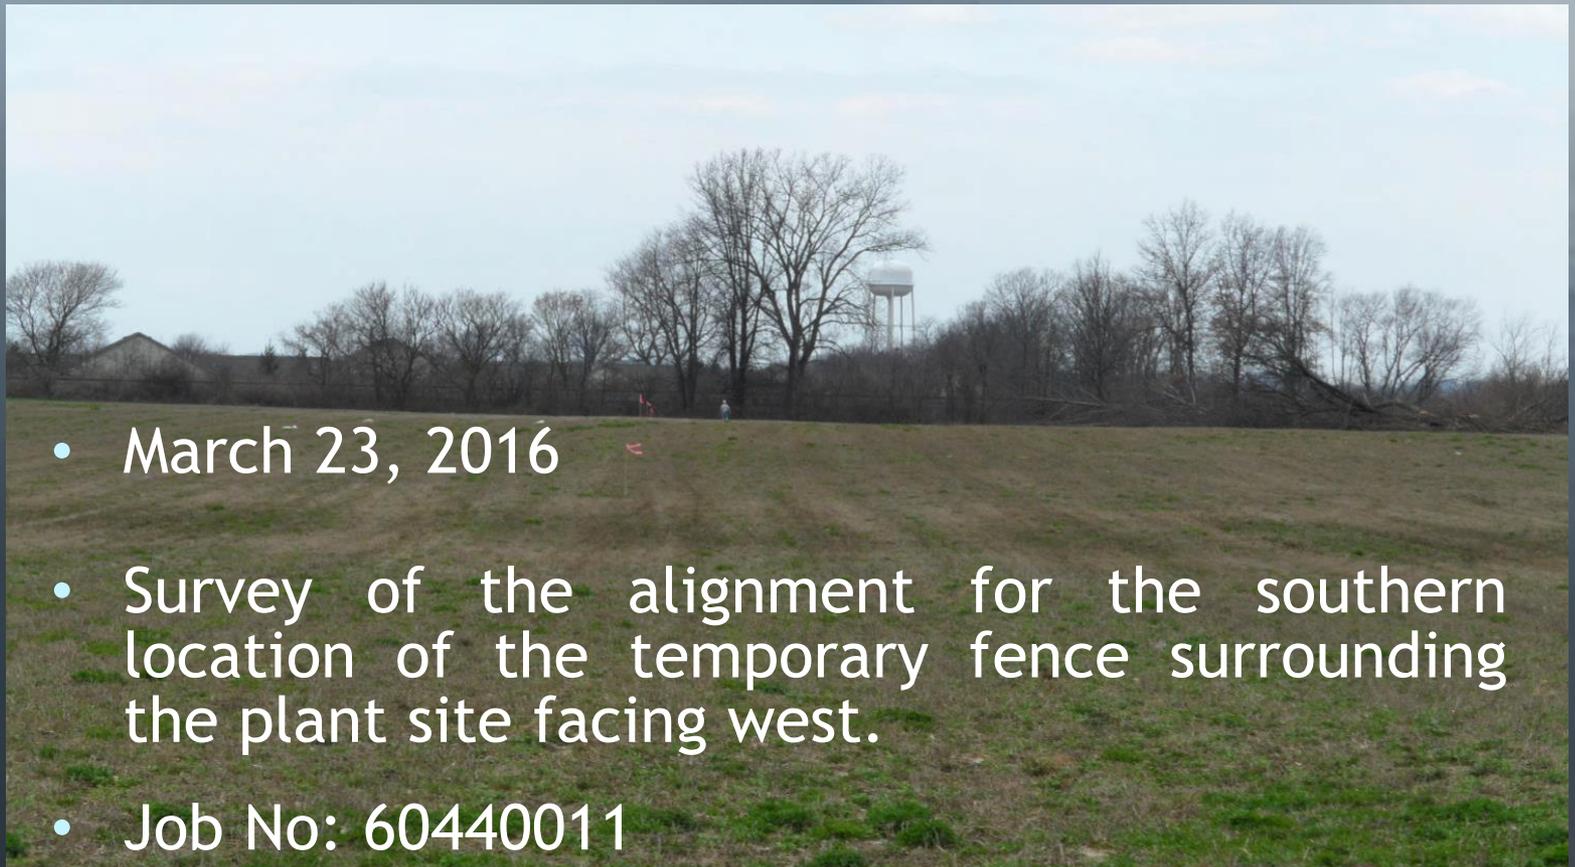
- March 23, 2016
- Survey of the alignment for the southern location of the temporary fence surrounding the plant site facing west.
- Job No: 60440011

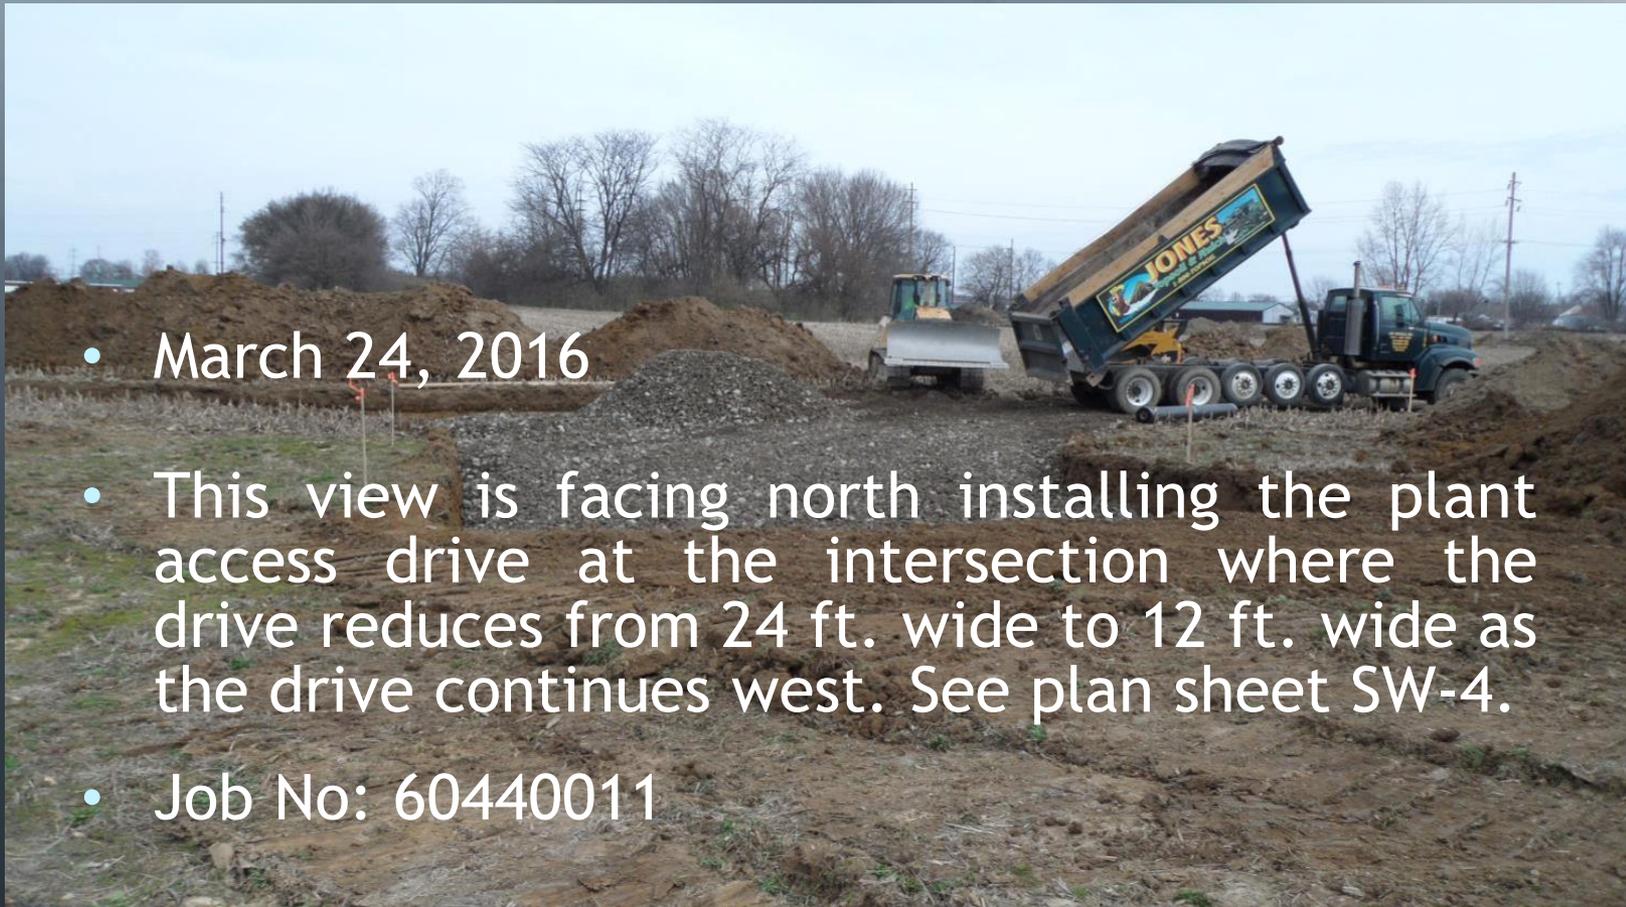
- March 24, 2016
- This view is facing north installing the plant access drive at the intersection where the drive reduces from 24 ft. wide to 12 ft. wide as the drive continues west. See plan sheet SW-4.
- Job No: 60440011

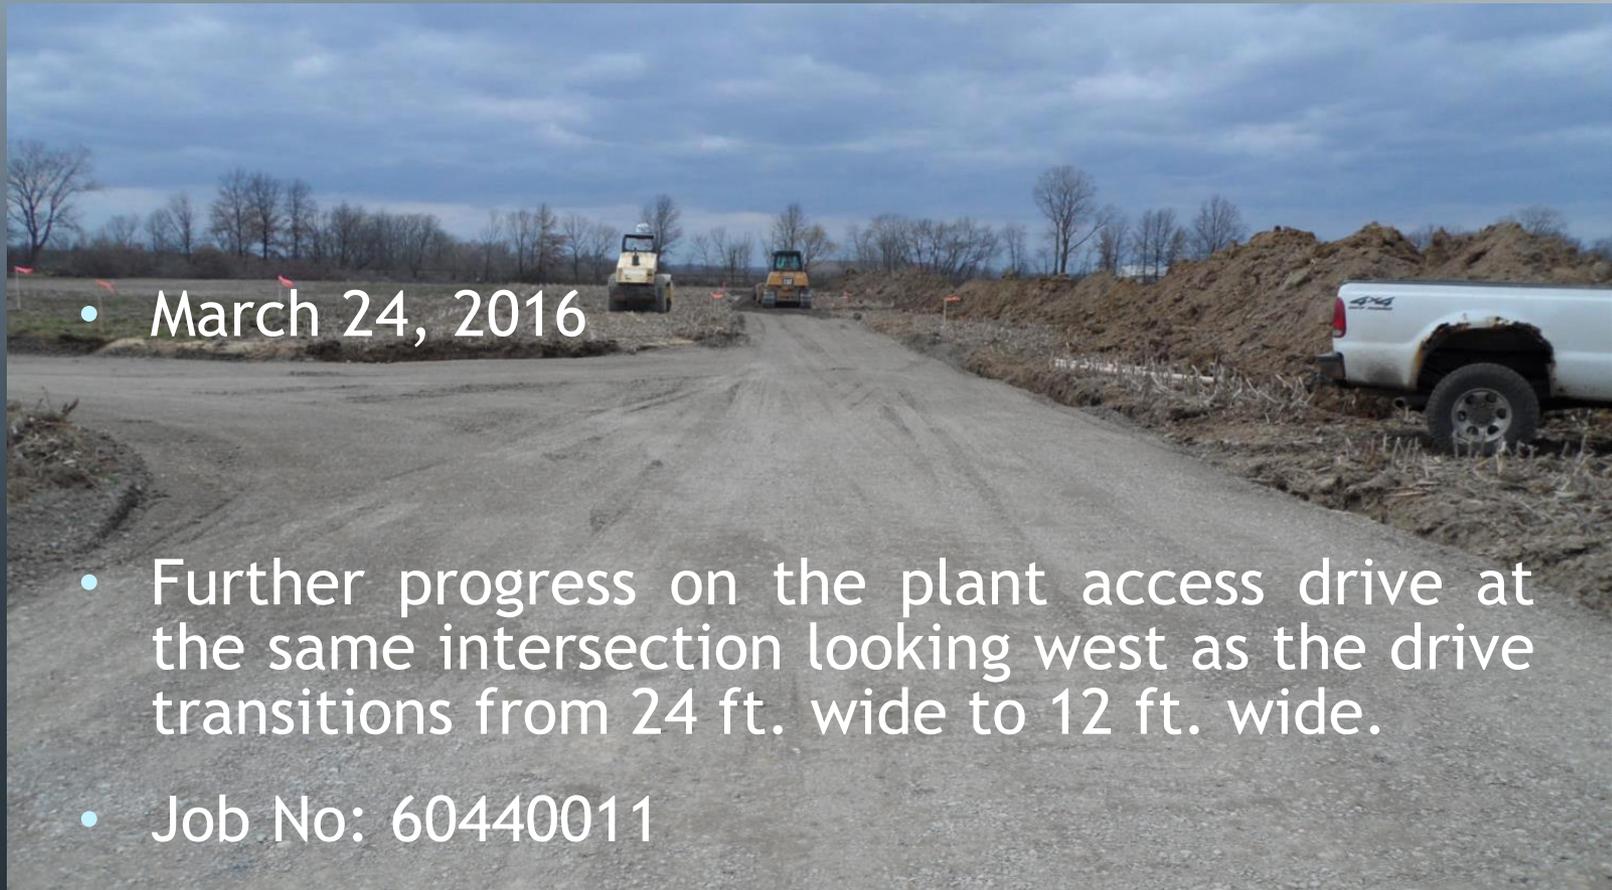
- March 24, 2016
- Further progress on the plant access drive at the same intersection looking west as the drive transitions from 24 ft. wide to 12 ft. wide.
- Job No: 60440011

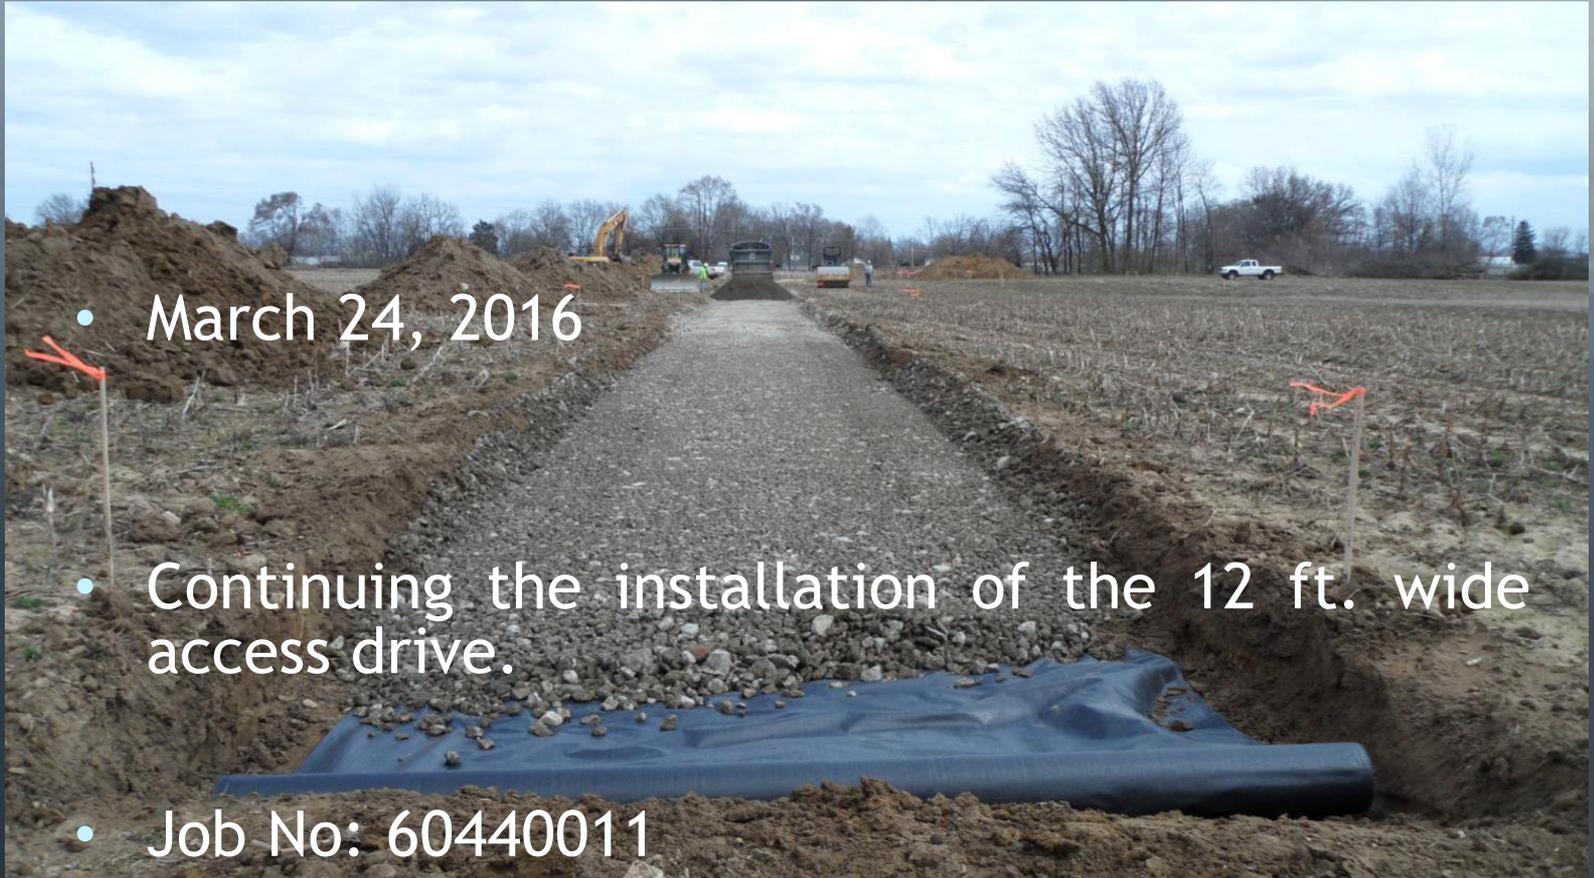
- March 24, 2016
- Continuing the installation of the 12 ft. wide access drive.
- Job No: 60440011

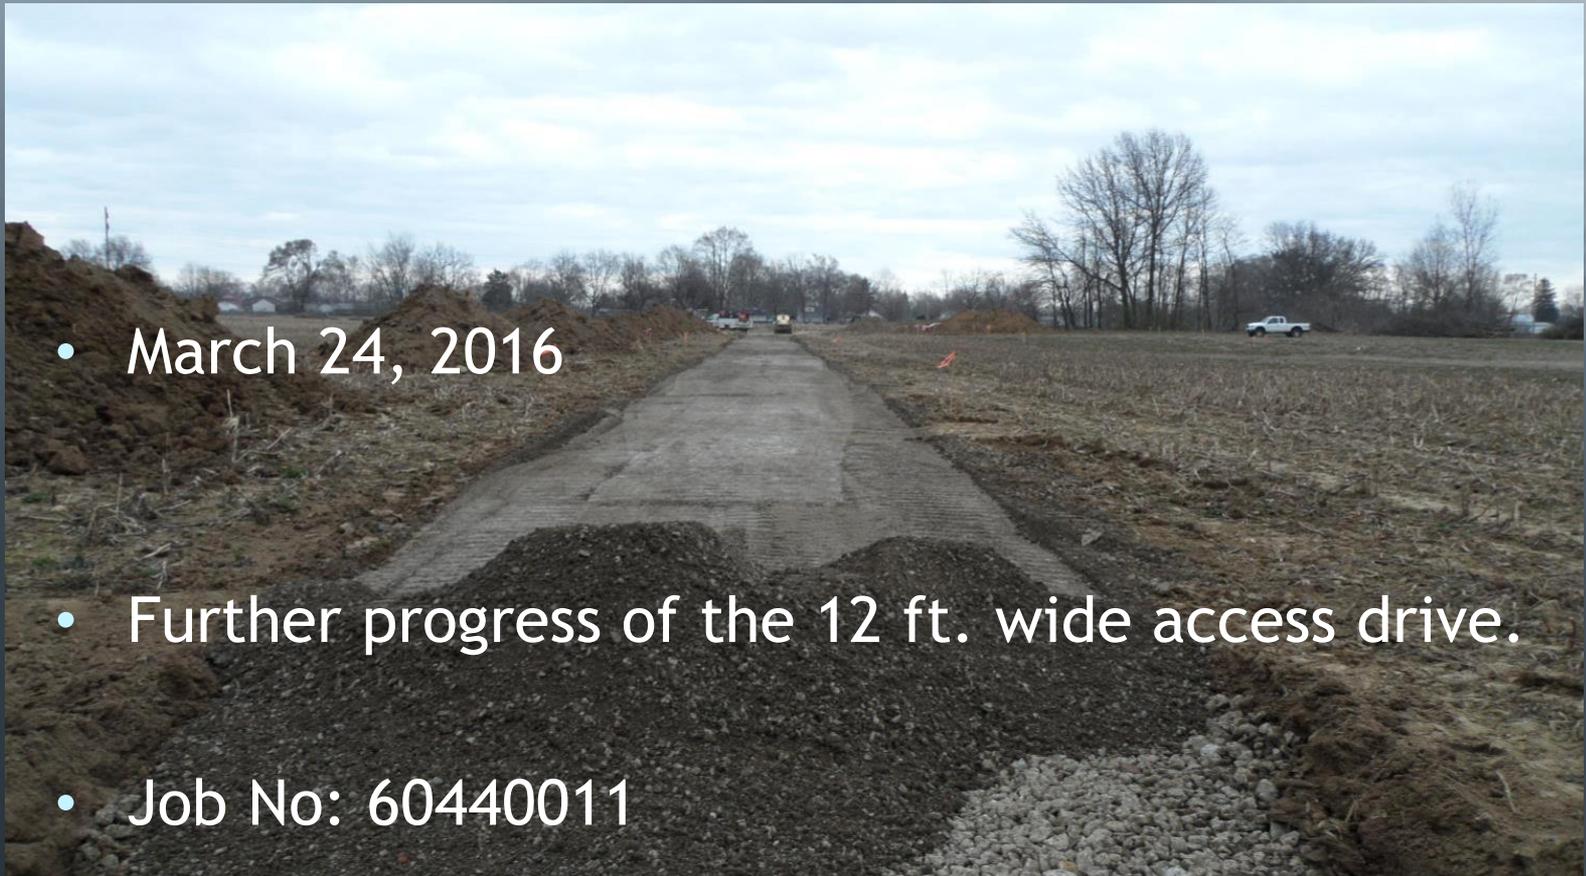
- March 24, 2016
- Further progress of the 12 ft. wide access drive.
- Job No: 60440011
